Technical Report CHL-97-17
August 1997

Periodic Inspection of Humboldt Bay Jetties, Eureka, California

Report 1

Base Conditions

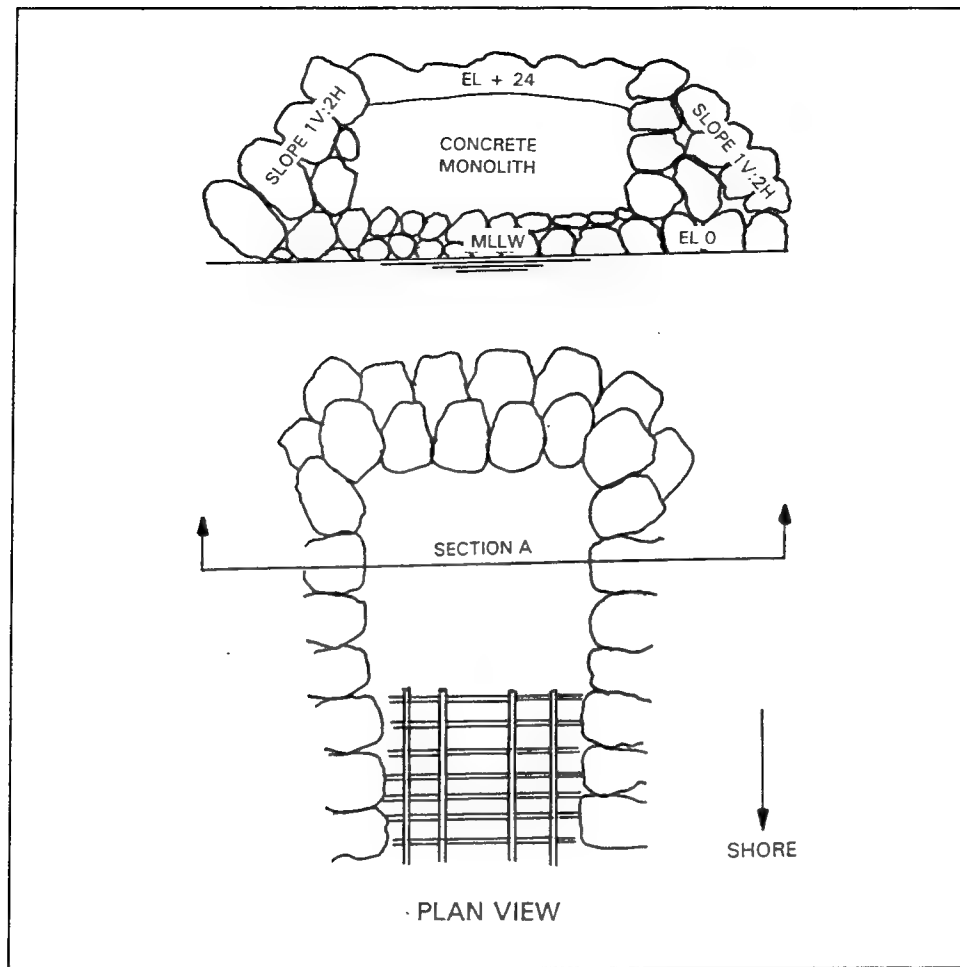
Figure 2. Concrete monolith structure constructed on south jetty in 1911

The head of the south jetty, which had been subjected to some of the most severe damage, was reinforced with a concrete monolith that was 9.1 m (30 ft) wide and 4.3 m (14 ft) deep (Figure 2). The 861,825-kg (950-ton) monolith was placed in the center of the head and armor stones up to 18,140 kg (20 tons) were laid up adjacent to the monolith. The el of the head was raised to +7.3 m (+24 ft) and the voids between the armor stones were filled with stones of not less than 227 kg (500 lb) in weight.

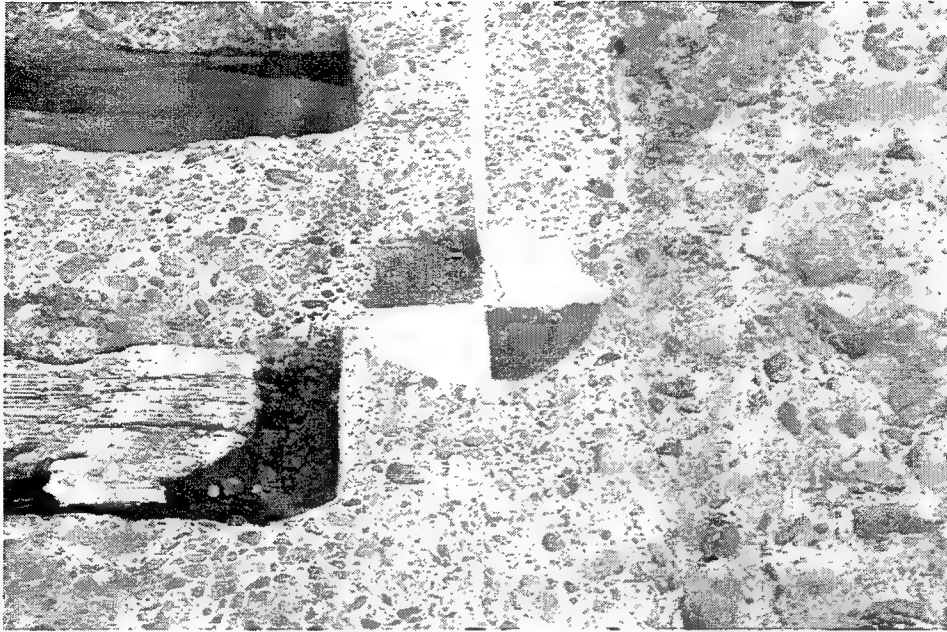
Figure 9. Typical target established on dolosse at Humboldt Bay

In addition, targets were established on selected dolos armor units to serve as control to check the accuracy of the photogrammetric work. Targets were 20.3 cm (8 in.) in diameter and divided into four quadrants, which were painted alternately white and black. A typical target is shown in Figure 9. This style of contrasting target provides a precise center point for which measurements can be made by both land and photogrammetric surveys. A high quality epoxy-based marine paint was used to minimize the need for repainting, and a 0.64-cm (1/4-in.) hole was drilled at the center of each target for identification in subsequent surveys.

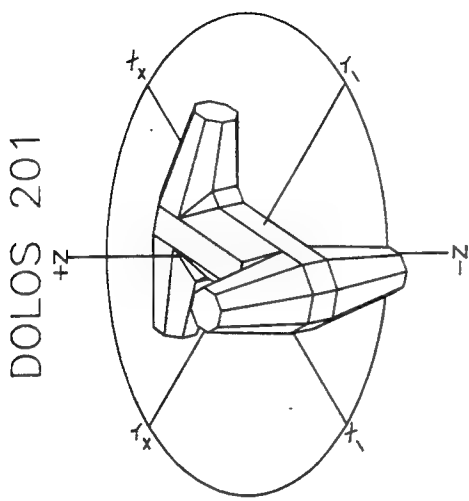
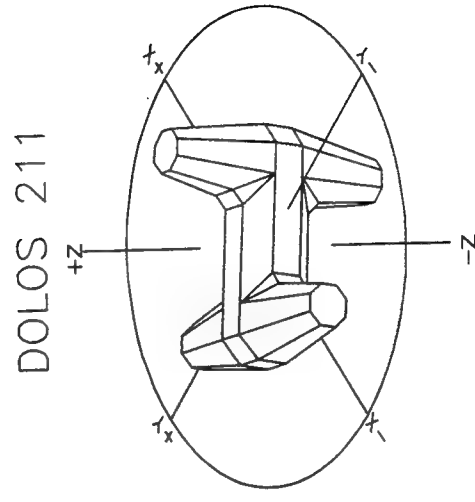
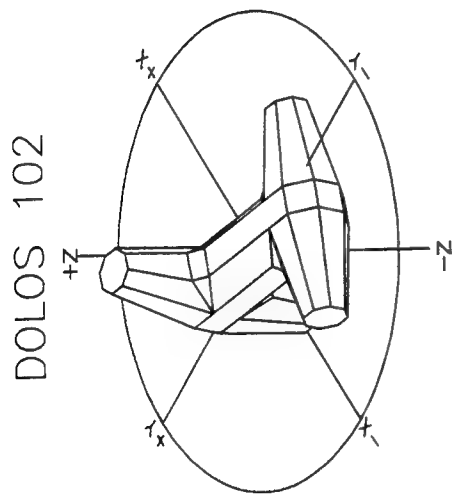
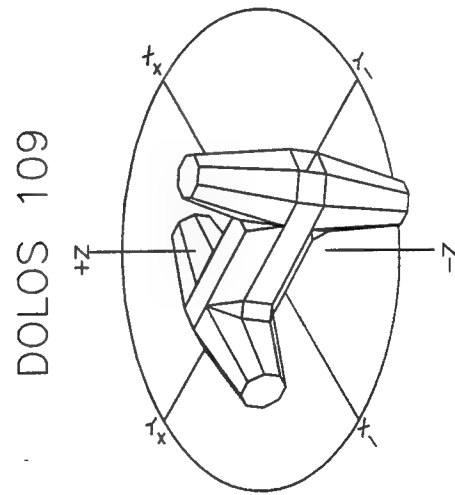
Figure 16. Representative targeted dolos armor unit positions relative to x, y, and z axes

Additional analysis was conducted for the dolosse with three targets. With the x, y, and z (easting, northing, and el) coordinates defined for each target on the various armor units, the centroids of each targeted armor unit were computed. In addition, the position of each armor unit relative to the x, y, and z axes was determined. Figure 16 shows the orientation of representative armor units to the three axes. The centroid of each targeted dolos and each armor unit's orientation (rotation angle relative to x, y, and z) are presented in Table 3 for the aerial survey results. These are base level conditions from which comparisons can be made in future surveys.
